## Report

On engineering and technical audit of real estate properties  
located at:

Moscow, Derbenyovskaya str., 11A (bldg. 9A, 15, 20)

April 2017

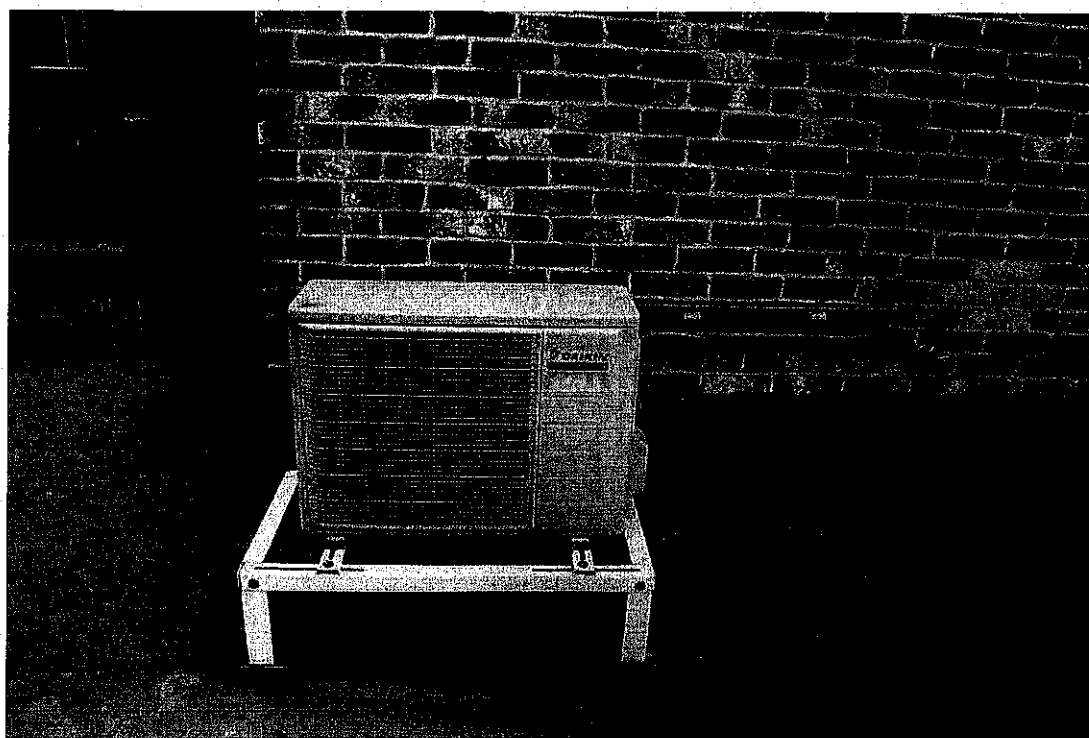
*Picture 6. Outdoor conditioning unit, installed on the roof. Source: Knight Frank St. Petersburg*

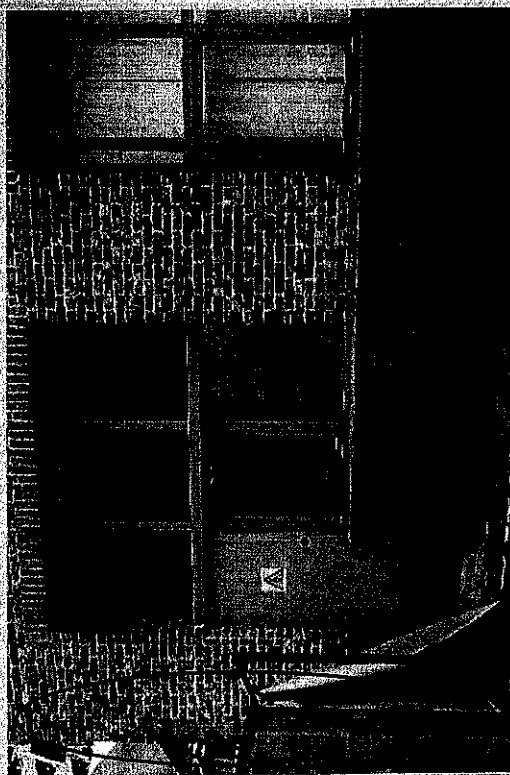
Building 15

Part of brickwork on the front of building fell down. This is not critical

It is required to repair brickwork according to working drawings.

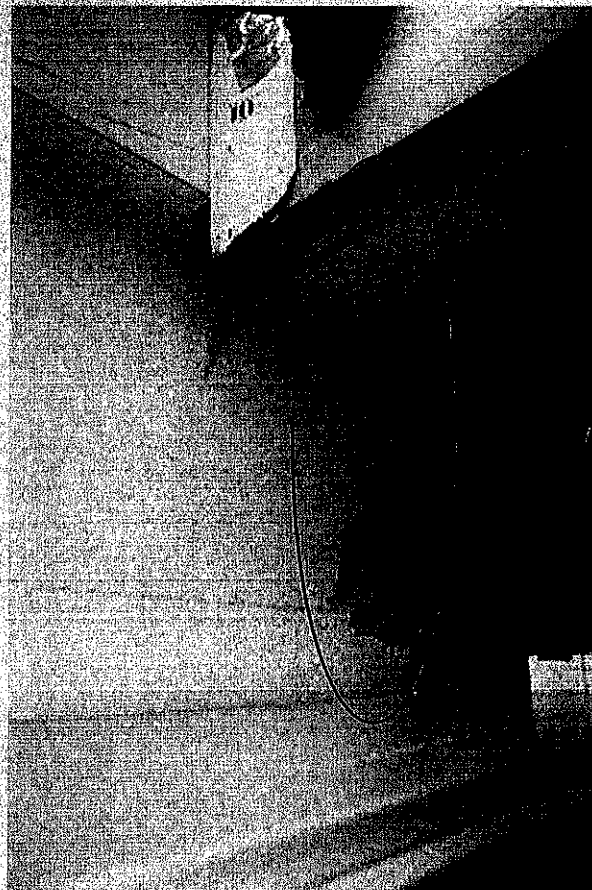
Building 15

The grounding bus bars are not painted. Inspection Act and grounding bus bars, do grounding sign on the building testing and get inspection are missing. Violation of Act.

**Electrical installation code,  
Article. 1.7.**

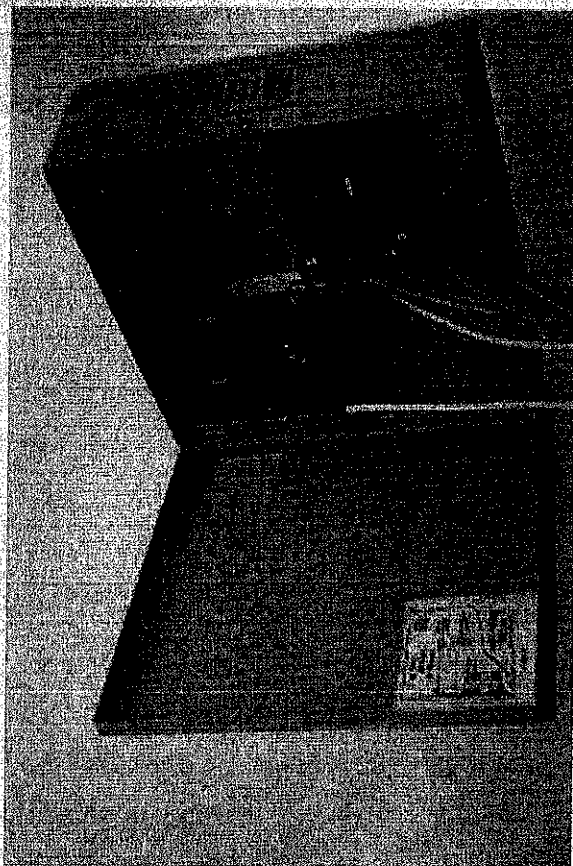
Building 15

Grounding contact on hatches of electrical cabinets and switchboards is missing.

**Breakage of Electrical installation code, Article. 1.7.**

It is required to do grounding of cabinets, switchboards, hatches.

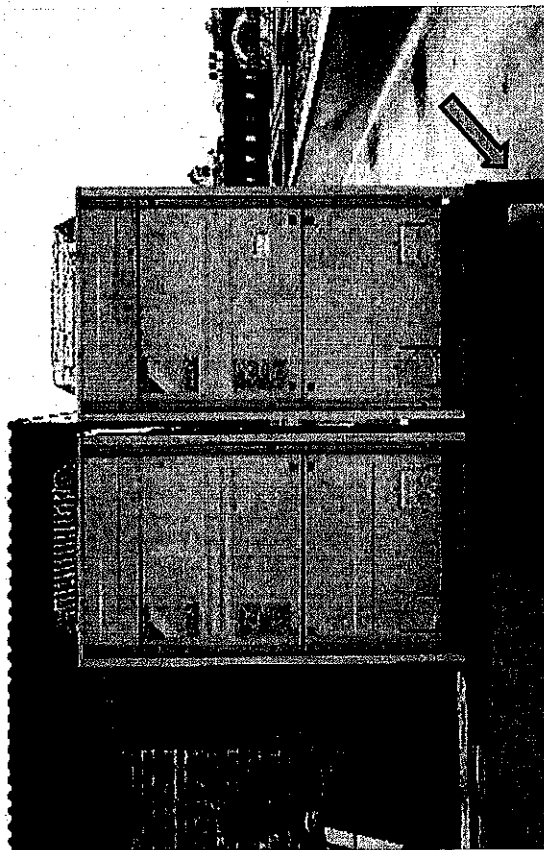
Building 15

Ventilation equipment frames are not painted.

**Significant violation of GOST 15467-79**

35. Priming and painting as well as anti-corrosion treatments are done on poor cleaned surface, number of covered layers does not comply with project requirement.

Onsite Inspection and checking after the works fulfillment.

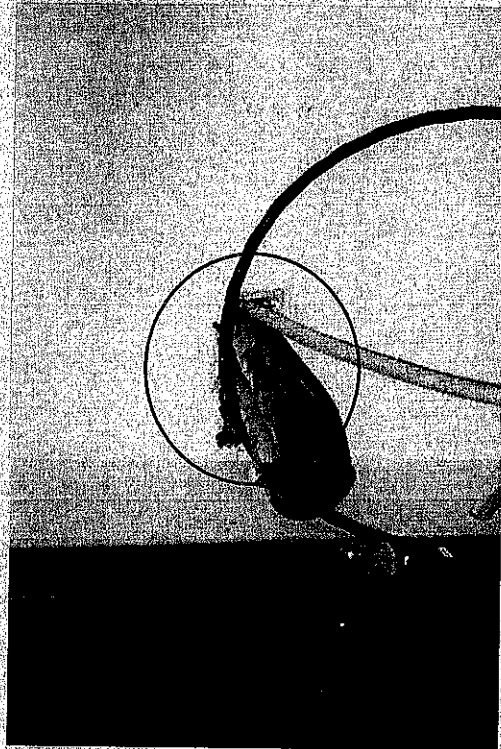
Building 15

- 3) There are no leads-through in the places where cables and pipes go through walls and barriers which limits fire spreading of the Object. In case of fire there is danger of fire and smoke penetration to the neighbor rooms. Violation of Federal Law – 123.

Places where pipes go through walls are made without leads-through and sealing. **Violation of fire protection norms as per Federal Law 123.**

It is required to meet fire safety requirements for cabling and piping in walls and floor structures  
On site inspection and checking after the works fulfillment

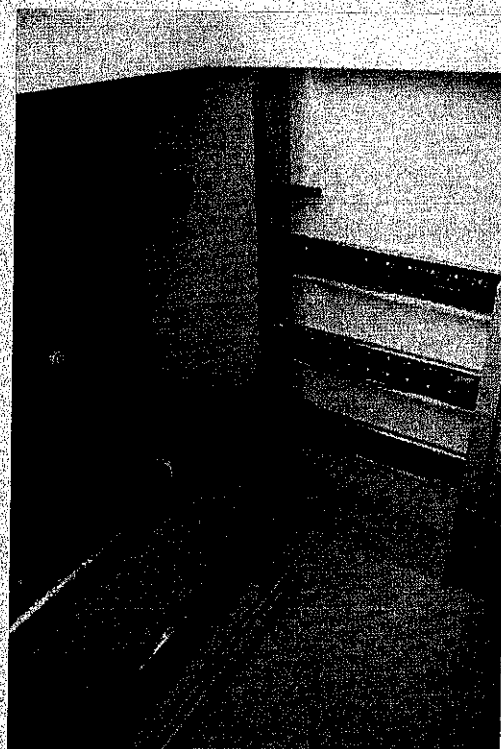
- 2) Fire protection wall (wall of type 1) with is connected to floor structure in the electrical switchboard room is made with flammable material (polyurethane foam), which does not comply to fire protection regulations (Federal Law – 123).

Junction of wall in electrical switchboard to floor structure is made with flammable material. **Violation of fire protection norms as per Federal Law 123**

Improve junction according to architect inspection.

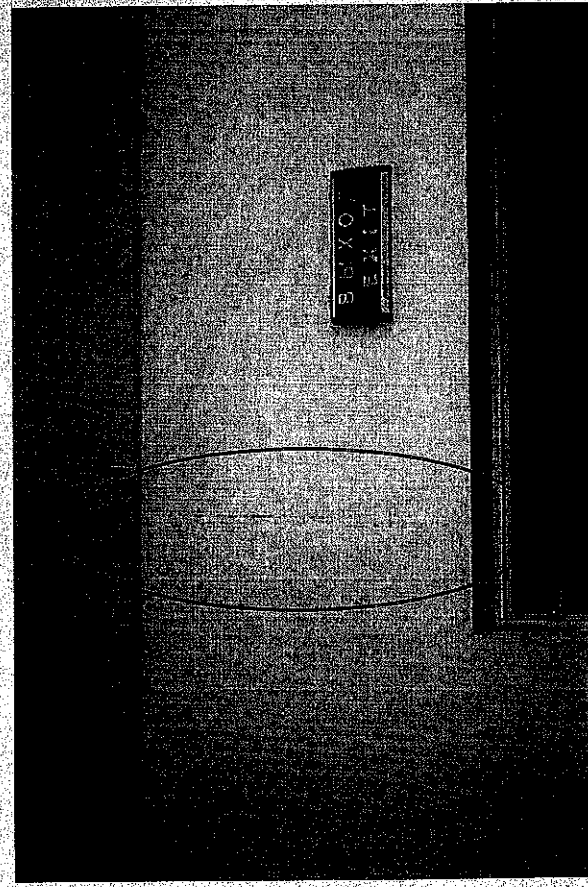
Building 20

Crack above doorway (floor structure was reinforced under newly installed wall of the 2nd floor). As-built documentation on beam reinforcement is missing.

**Critical violation as per GOST 15467-79**

9. Cracks in support area of bending structures along the main unit pulls (inclined lines from support)

**Significant violation as per GOST 15467-79**

Make additional survey of crack appearance causes and provide as-built documentation for the works (floor structures beams reinforcement).

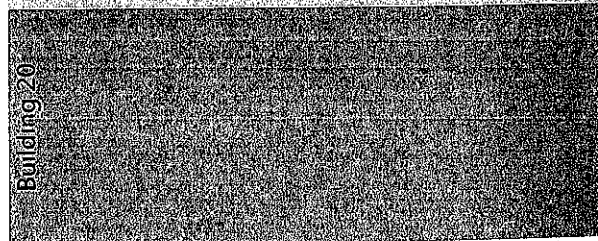
Step spalls at the building entrance  
Granite steps replacement  
Aesthetic defect

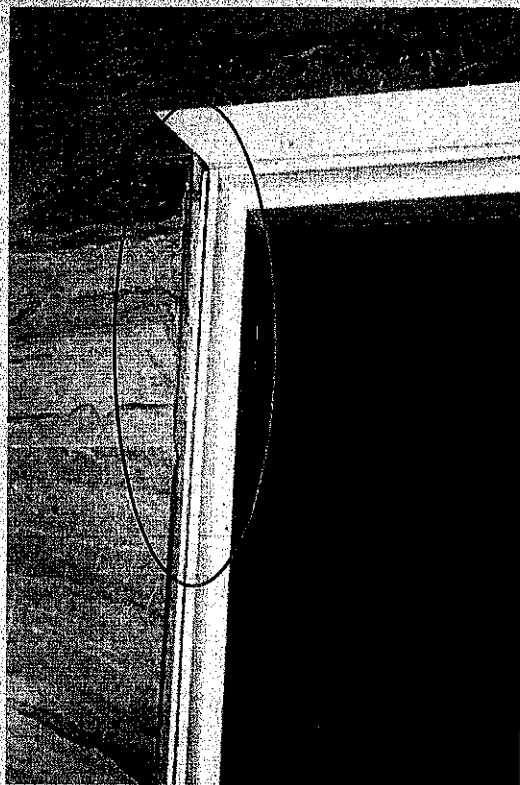
Building 20

The door lining is not finished.  
Aesthetic defect.

Finalize the finishing works
